The following article was published in the Jaguar Driver magazine, September 2016, and is reproduced here with kind permission from the author, ALAN HAMES, C.Eng., MICE, MCIHT
Alan is a multiple concours winner in UK, with his 1972 E Type V12, which he has owned from new.

Stromberg carbureted V12's Hazardous Petrol Leaks in Engine Compartment

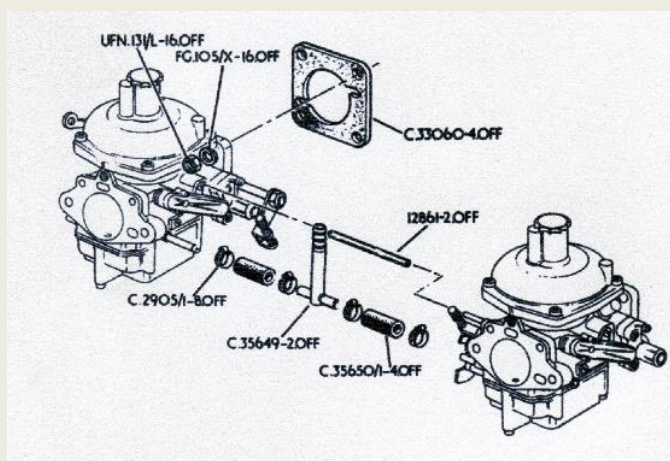
As those of us who are mechanically minded and have a basic knowledge of the carburetor operating system, we will be aware that there is a somewhat unexplained small bore clear, (or green), plastic tube linkage between the carburetors on both the nearside and offside twin carbs. This does not have any obvious function and when the bonnet is lifted when cold, or when the engine is at operating temperature, this tube does not seem to have any fuel visibly passing through. However, it has an important job to do when starting the car from cold and when operation of the choke is necessary, as this allows fuel to pass through to enrich the mixture.

A close inspection of these short and inaccessible tubes, that over the years are likely by now to be well discoloured brown from the passage of fuel for so many years, makes any assessment from above very difficult. In my case this was the situation and the arising split in the tube could not be seen and could have been the cause of a fire, fueled by streams of petrol on both sides. When the tubes are removed it is clear that the sharp bends at each end, where they locate over the carburetor brass tube stubs causes them to fracture at this point which cannot be seen.

Manual turned up their original Part Number 12861. However, as expected, this cannot be obtained from Jaguar, as this is now a superseded part. In my case, with my store of so many hoarded parts I was able to replace one with an old original Jaguar part, but the other one required some web searching for tubing suppliers and the purchase of a suitable length, so I am pleased to say that my problems have been solved. Anyone else needing the part I am sure will find that this can be sourced from various of the Jaguar Parts suppliers, but be careful to ensure that whatever is on offer is a tube that is petrol resistant, as some plastics are not suitable and may even be too flexible and not heat resistant enough for this location.

As I said above, take note of the warning and carry out a check on your car, (and the other small rubber connecting tubes in this area), as I am sure that many V12 owners will be unaware that there is a problem in waiting that could be not only costly, but with petrol in mind also life threatening. Hopefully a simple check carried out before the next trip will avoid a potential disaster to one of our treasured cars.
