## **A Second & Serious V12 'E' Type Petrol Leak and Fixing Procedure**

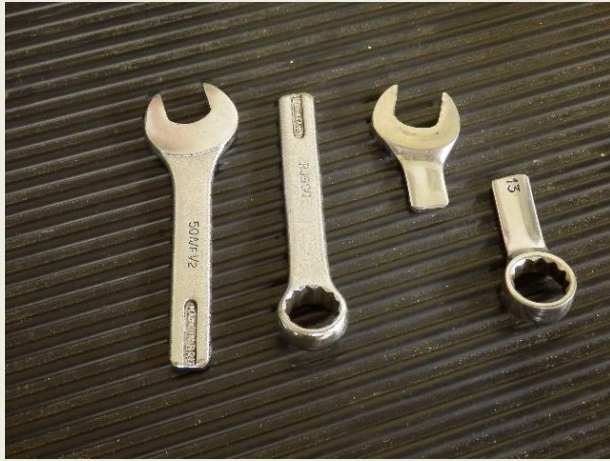
**Carburettor Removal - Req'd. Cut Down Spanners**

A strip down of linkages, pipework, air cleaner box and the main petrol feed was therefore essential and proceeded with invaluable help from my son Ashley, who handed spanners and other tools to me to speed up the operation. The carburettor itself was not an easy removal, as one of the bottom retaining nuts is almost completely inaccessible and no spanner could shift it. However and by chance, an RAC patrol was fixing a car opposite my home and a call for assistance was happily answered. He too found the same problem, but not deterred cut one of his spanners in half to fit into the restricted area and with this successfully achieved the near impossible. His help clearly reinforced the value of being an RAC member and on leaving he donated the two spanner halves to me, to ensure that I would have no further difficulties. A cold drink for him on a hot day being the only cost - good old RAC!! A useful suggestion at this point, when taking so much apart, try to put an old towel in place under the work area to catch that elusive nut or bolt, which will inevitably escape the fingers and then find its way into an inaccessible corner. It certainly saved me on a series of occasions!!

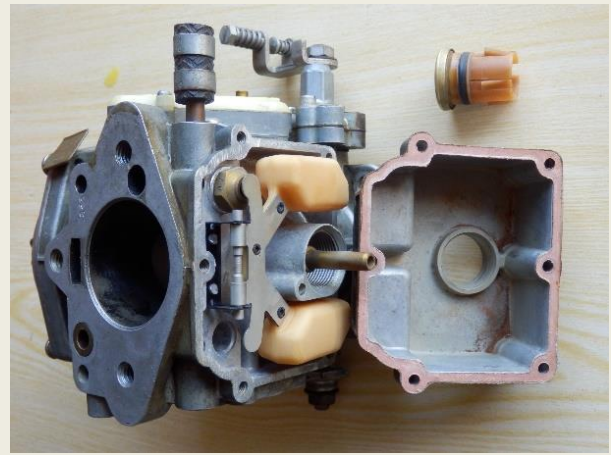
With the one carburettor removed, it was then clear that the problem was located in the underside of the float chamber, which was awash with fuel. Dismantling soon found that the bottom sealing plug was spinning loose due to failure of the internal rubber sealing "O" ring, which had flattened and hardened. A call to my local Jaguar Distributor found, on this occasion, that this small and essential part is no longer listed by Jaguar, but once again my friendly man at S N G Barratt came to the rescue, with new parts delivered overnight, so not delaying the repair. With one faulty float chamber and so much dismantled, it was clear that both nearside Strombergs needed to be removed for a similar repair, which then followed. Later all four carburettors will have to receive the same treatment, as the likelihood is that all will subsequently suffer the same problem.

**Carb. and Failed Float Chamber Base Plug**

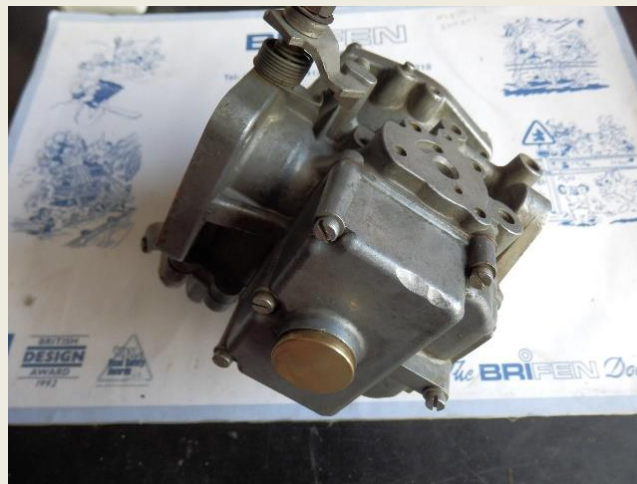
During reattachment of the float chamber bottom alloy casting, it was noticed that there was a fretted area on the external edge of the float chamber, which had extended to about half the casting thickness. This had arisen from the steel braided petrol return hose over the years touching and abrading the float chamber base. This was corrected by re-angling the braided pipe, but is another area that I suggest is inspected by all V12 'E' Type drivers, as over time this could wear a hole through the float chamber base.

**Base of Float Chamber Fretted by Steel Braided Petrol Return Pipe**

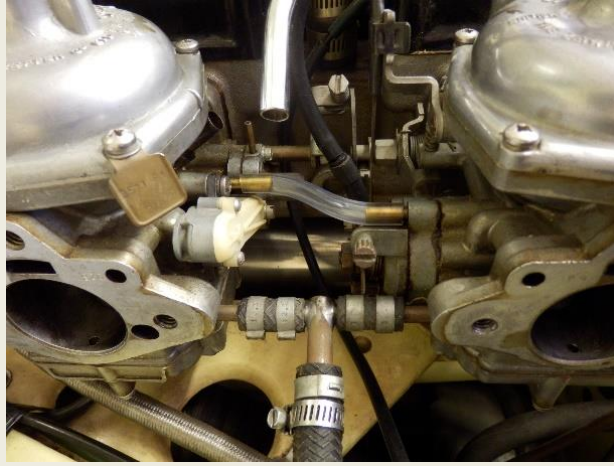
With the major leak now resolved and all apparently well, the ignition key was turned and the petrol pump kicked in. But, being by now so aware that one leak seems to lead to another, a further inspection was made before firing up the engine. A good move, as the bottom main fuel linkage, via a Tee piece to the two float chambers, was leaking on both sides. An easy diagnosis determined that the now 44-year-old four crimp connectors on the two rubber tubes had all loosened, requiring either a recrimping, or the substitution of four new small jubilee clips. (I was happily able to manage a careful recrimp of the original clamps.)

### **Left & Right Petrol Feed Rubber Tubes Crimped onto T Piece & Causing a Third Leakage**
