=====  
**Friday, 16th October 2015**  
=====

## Cooling system

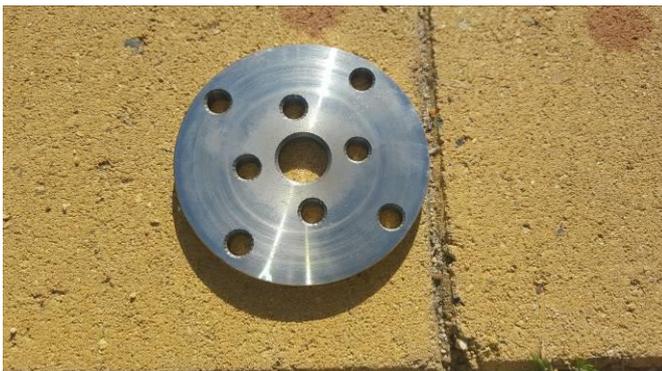
*Here's the adaptor plate, manufactured by Trevor Sweeney of Northern Hard Surfacers (in Bayswater Road). They do excellent work, and no job is too small for them to undertake - and they don't charge an arm and a leg - just the arm!*

However the (!@#%) coupling is still fouling the radiator. A discussion with the technical boys at The Jaguar Driver Magazine (UK) was of little help, so I've had a plate made to mount the fan directly to the water pump so I can run without the viscous coupling. A temporary solution while I nut out a more permanent and acceptable fix. Not totally satisfactory - yet!

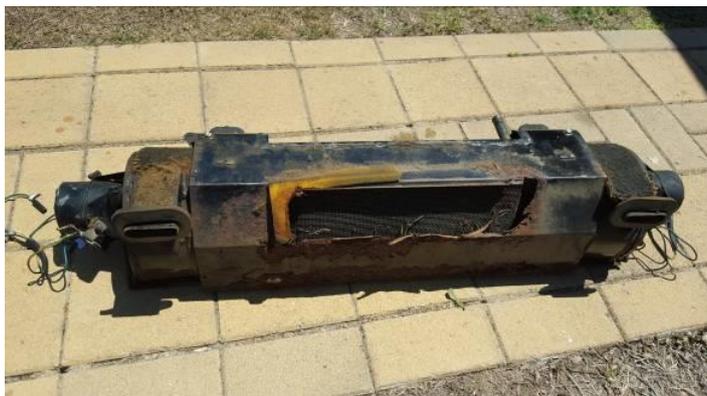
*The rusted-out heater box.....*

I removed the heater box (which requires removal of the cam covers) to find the heater matrix was completely rusted out, so a new matrix was fitted to the heater radiator by Bayswater Radiators. The rusted sections of the heater box were cut out and new sections fitted. It seems that the gaskets, cushions and seals

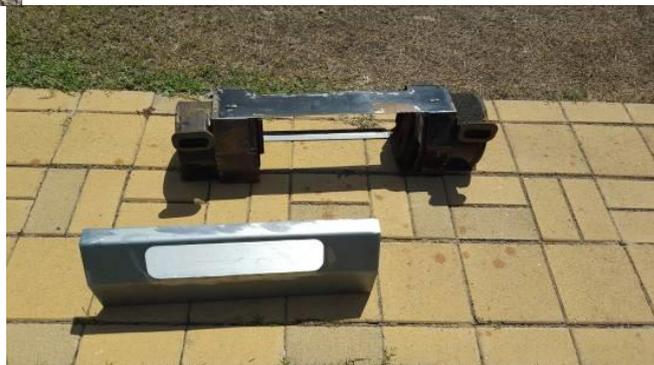
*.....and now the rust has been cut away, and a replacement plate manufactured by Trevor, ready for installation of the reconditioned radiator.*

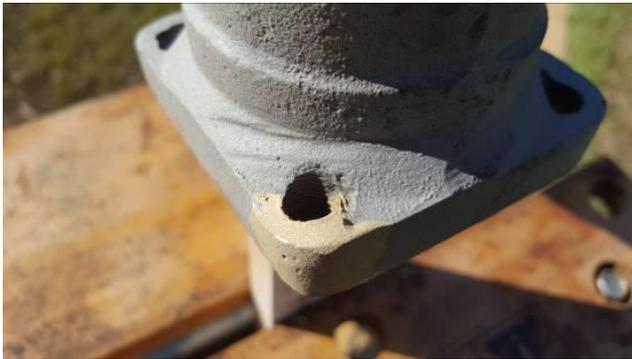
*This weld repair will be invisible when the manifold is painted - with high-temp paint of course!*

While running the engine, I noticed a blowing from the exhaust manifold where it connects to the exhaust downpipe, so, after the engine had cooled, I removed both of the manifolds - and a good thing too, because the studs connecting to the exhaust flange were in a very bad way. Only 3 per side were there, and the forward manifold flange was missing a stud hole - it had cracked off!

Another panic moment, because manifolds will be as easy to find as hen's teeth, and freight would be prohibitive. But I took them round to Bob Parkes in Anne Street, and they referred me to Trevor Sweeney at Northern Hard Surfacers, who was confident he could fix them both up by weld-filling the broken piece, and repairing the stud threads - and the following day they were ready, for much less than I had expected to pay.

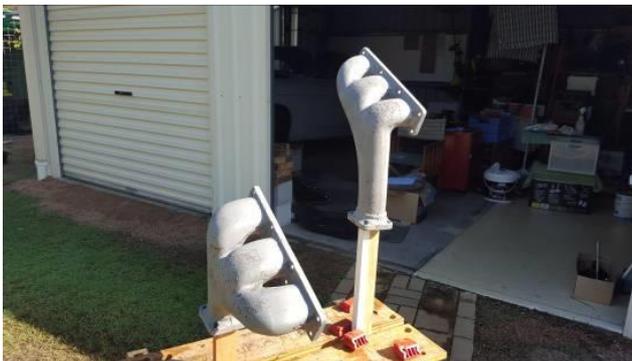
*The manifolds, freshly sand-blasted and waiting for a protective coat of paint.*

Of course, when you get this far with a job, you have to finish it properly, so I took the repaired manifolds to Tony at Bare Naked Industries, who sand-blasted them back to bare metal, ready for painting up with high-temp matt black paint (POR 15).
