Jaglog

Part 3

______ Battling on with my 1965 4.2 Mark 10 (Caspian) Sunday, 21st June 2015

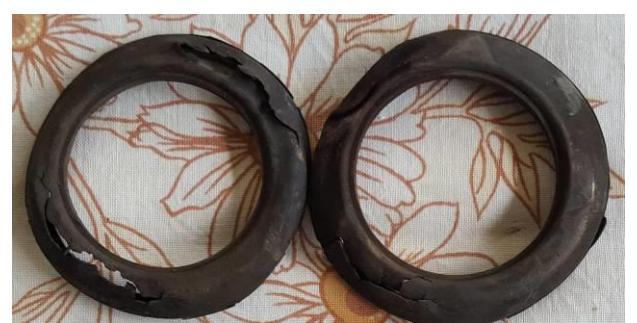
Yes, this is what the old calliper dustboots looked like, No wonder the pistons were u/s. I sourced a new genuine calliper kit from USA, through Ebay.

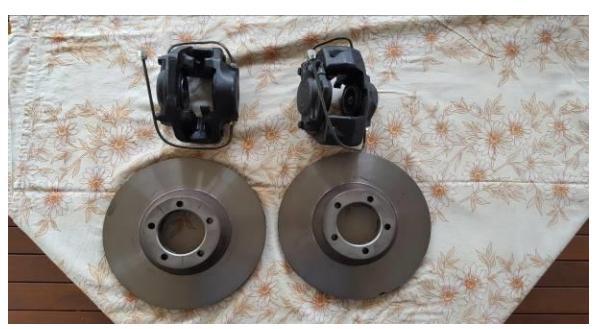
Good as new, and ready (nearly) for action! Great job Greg. Thanks to you and all at Brakeforce.

One brake rotor had a small chip on the circumference which made me suspicious that it might cause a roadworthy failure, so I took both of them to David Dimmock, who said he "probably" would pass them. In the hope that I can rely on his "probably", I've sent the front rotors and callipers off to Brakeforce, and they've come back shiny and new-looking. At last I can re-assemble something!!

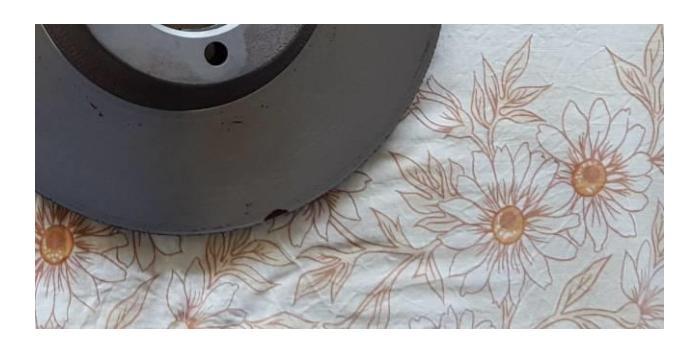
And here's the offending chip on the edge of the rotor, which appears on the reverse face as well.

The rotors have now been re-fitted, and the bearings re-packed. The rotors were skimmed down from 12.7mm to around 12.3mm - well over the minimum of 11.5mm - but re-fitting the callipers is a continuing challenge. I couldn't find my set of feeler-gauges anywhere, so I had to go out and buy another. I hadn't kept the old shims in any kind of order because I knew the brakes would have to be re-set, but I didn't realise how difficult it would be to manipulate these shims in to place - and every time I re-calibrate the clearances and calculate the required shim adjustment to centralise, the new unequal clearances seem to defy logic. Trial and error will no doubt get things right in the end, but what a pain!!
