Introducing Prince Caspian

Monday, 11th May 2015

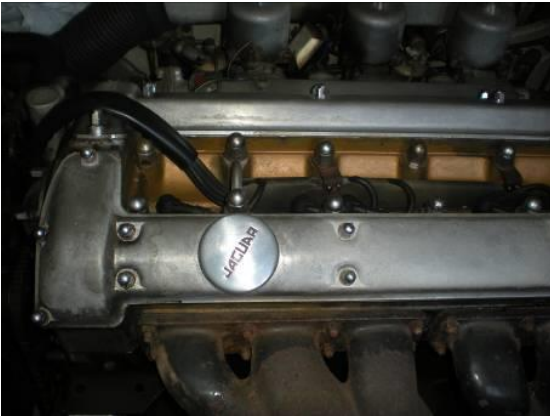
I have to restrain myself! I get carried away cleaning and scraping etc, when I should be focused on more important matters. But hey!, I've polished the important bit – the oil-filler cap.....
